E 16	Product/assembly/test step	
	Vehicle/engine

A1

Trouble-shooting program

Danger of Accident on Semi-conductor Ignition Systems

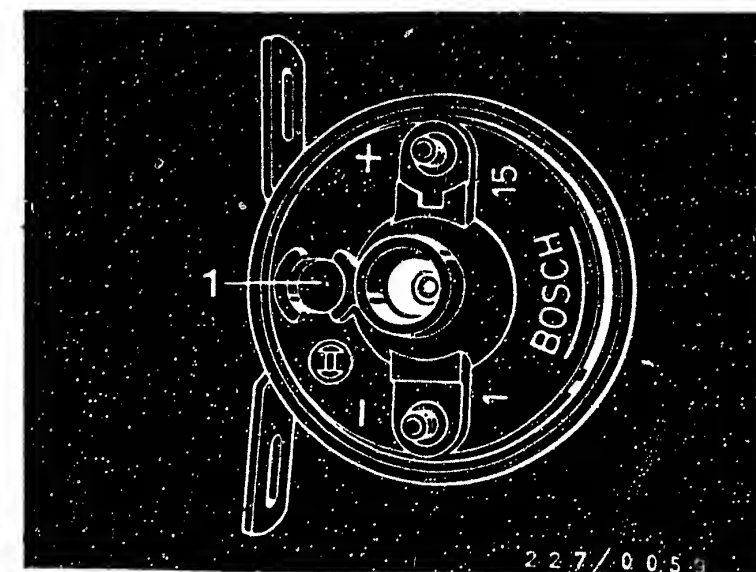
1 = Plug

Visual examination: Remove protective cap from ignition coil and check whether plug (see illustration) is in position and whether any sealing compound has escaped.

Electrical test: Ignition coil primary (term. 15 and 1) $0.5...0.8 \Omega$ (take resistance of test lead with test prods into account).
Ignition coil secondary (term. 1 and 4) $8.7...14.5 k\Omega$.

1. If plug is not in position and/or sealing compound has escaped, replace trigger box and ignition coil.

2. If resistance values are not O.K., replace ignition coil.

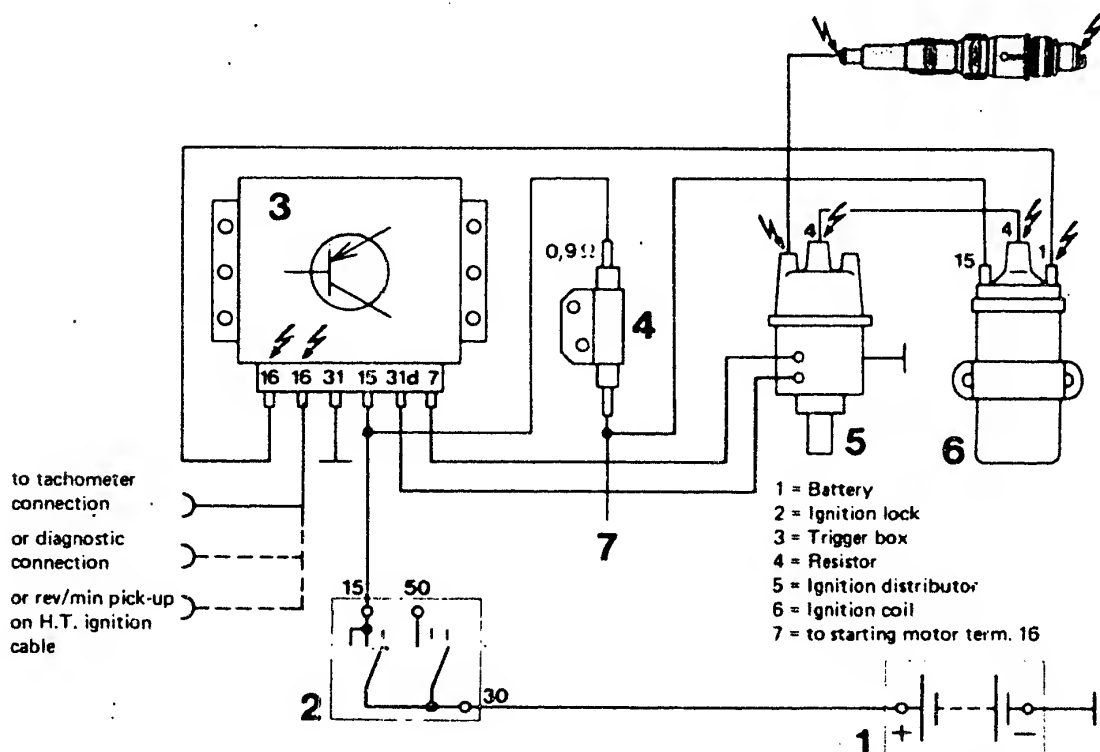
Terminal diagram

Below is a typical terminal diagram of a semi-conductor ignition system, the danger points are marked with red high-voltage arrows. We would point out that all semi-conductor ignition systems, even the older ones, are to be regarded as dangerous in the sense as defined by this bulletin.

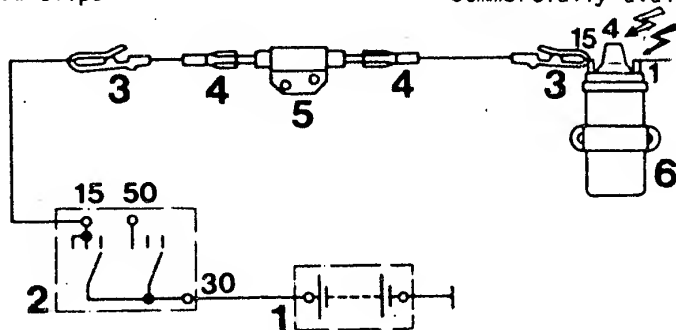
In comparison with conventional ignition systems, transistorized ignition systems with current limitation have different primary voltage characteristics. During the dwell period the voltage at terminal 1 of the ignition coil may assume values from 1.5 V to battery voltage (or greater). This may lead to an incorrect display of rotational speed and dwell angle when testing the ignition system. However, there is no functional defect in the ignition system, and, for this reason, the trigger box must not be replaced. Incorrect displays may occur with the testers listed below:

Connect a ballast resistor of 0.9 or 1.0 Ohm (see Fig.) in series in the line to term. 15 of the ignition coil (take care not to cause a short circuit). After the rotational-speed measurement, the ballast resistor must be removed (otherwise starting difficulties and misfiring). Connect tester as per operating instructions.
